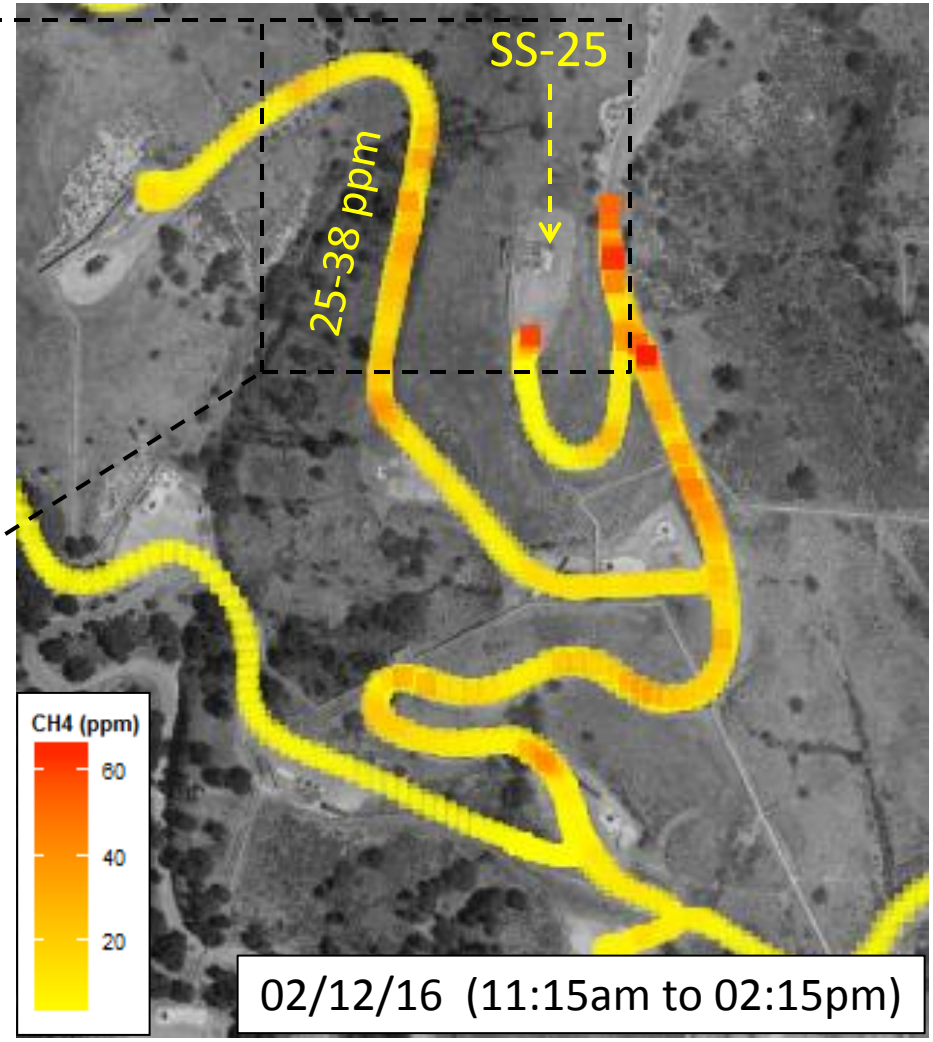
- Increased methane concentrations (up to 38 ppm) were measured ~200 ft NW of SS-25, probably from multiple naturally occurring holes on the side of the hill; SCAQMD inspectors used a portable TVA-1000 monitor to confirm these findings and complement the LICOR data
- SCAQMD staff collected a canister sample at this location
- Two FLIR cameras were also used to identify potential emission sources

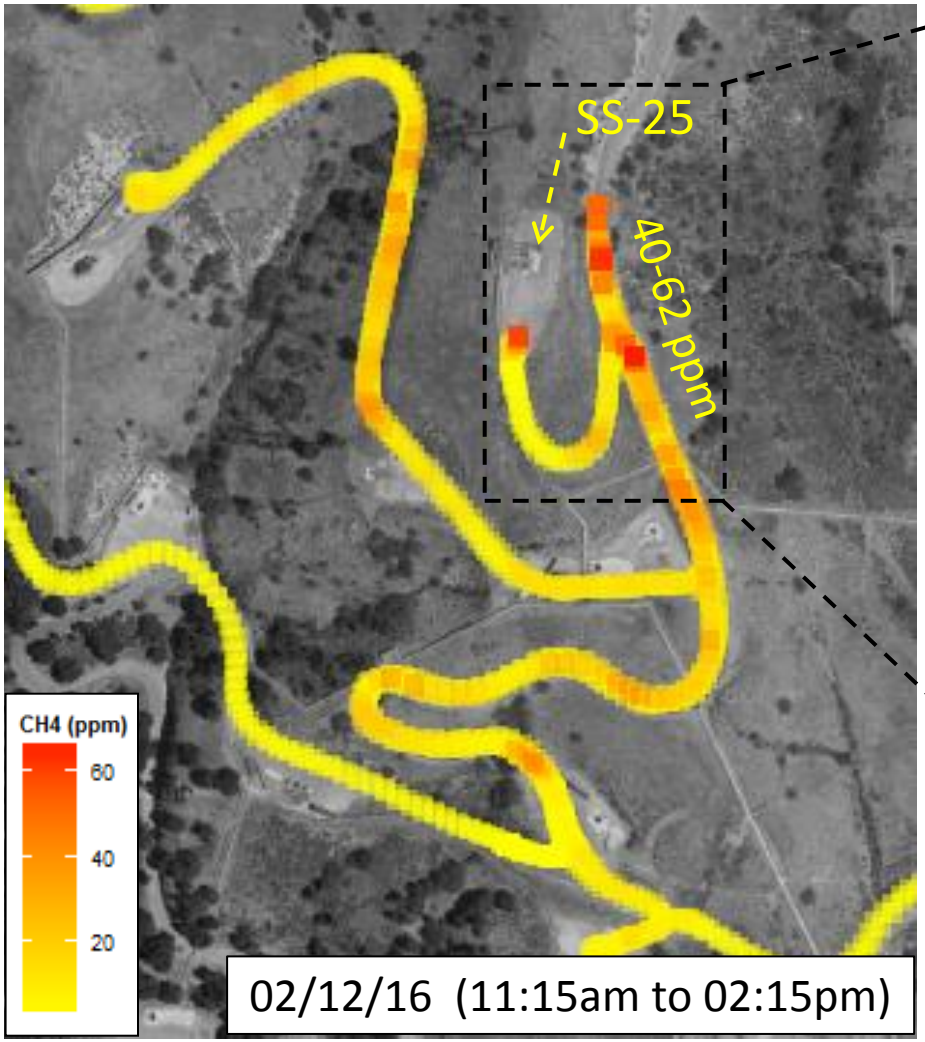
• Elevated methane concentrations (up to 62 ppm) were measured ~150-200 ft E of SS-25, probably from multiple naturally occurring holes on the side of the hill; SCAQMD inspectors used a portable TVA-1000 monitor to confirm these findings and complement the LICOR data; winds and methane concentrations were very variable

• SCAQMD staff collected a second canister sample at this location

• FLIR cameras identified a “weak” emission plume flowing downhill from the SS-25 well; occasionally a smell of mercaptan was detected

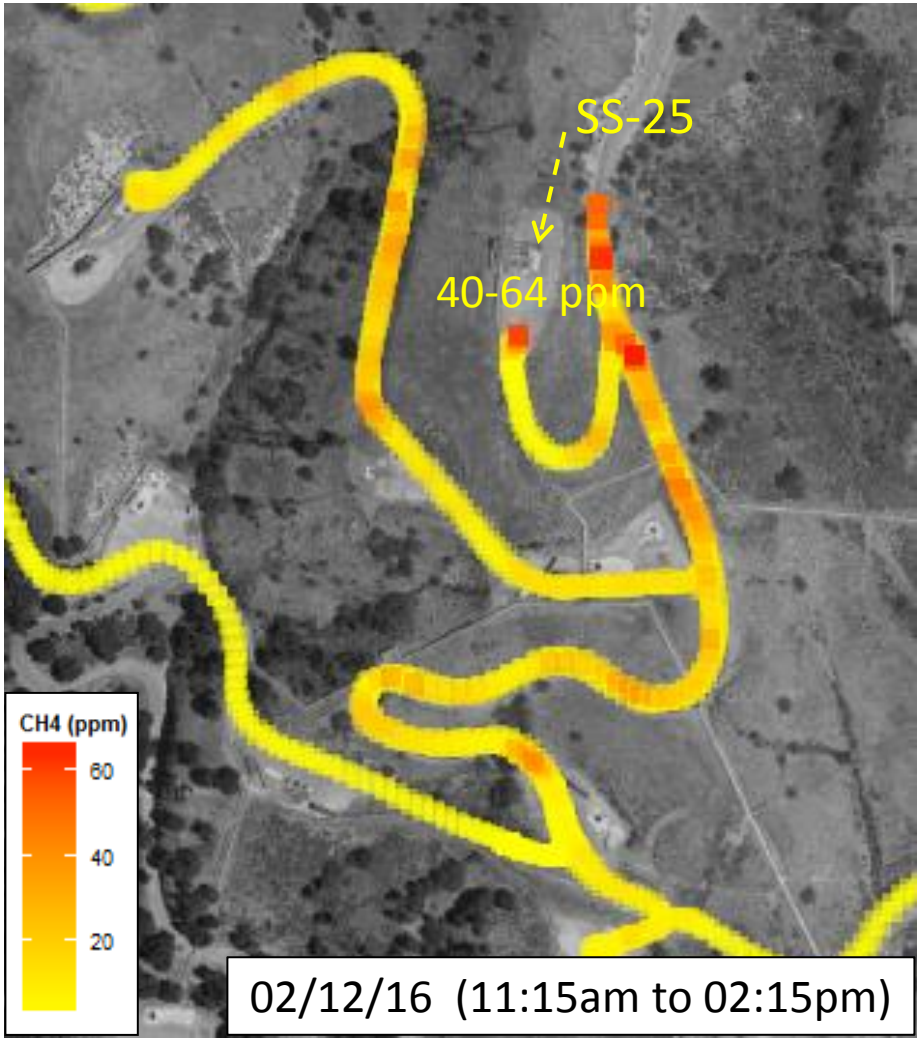
- Elevated methane concentrations (up to 64 ppm) were measured ~80 ft S of the SS-25 well's head; SCAQMD inspectors used a portable TVA-1000 monitor to confirm these findings and complement the LICOR data; winds and methane concentrations were very variable
- SCAQMD staff collected a third canister sample at this location
- FLIR camera videos taken several hundred feet NW of SS-25 by SCAQMD inspectors and SoCalGas staff did not show the presence of a natural gas leak from this well
